PRESERVATION OF WALLPAPERS AS PARTS OF INTERIORS

**Preservation of Wallpapers as Parts of Interiors.
Addressing Issues of Wallpaper Conservation on the Basis of
Projects Carried out in Austria, Estonia and Romania**

Doctoral thesis
Doktoritöö

Estonian Academy of Arts
Faculty of Art and Culture, Department of
Conservation and Cultural Heritage
2013

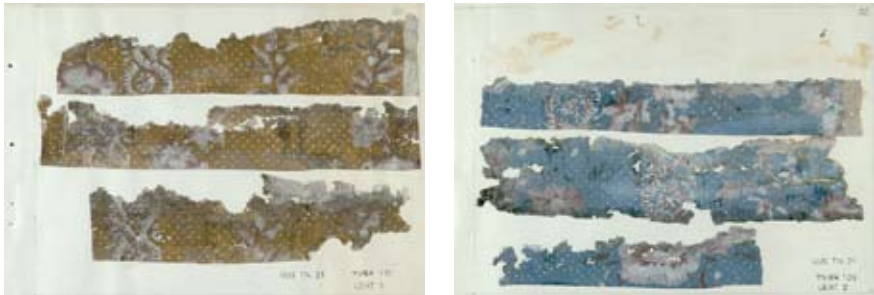
Figure 38. Fragments of two Rococo wallpapers found in Uus 21, Tallinn.
ERA.T-76.1.10712.

Other examples from the second half of the 18th century show the tonality and patterns characteristic to Rococo. Fragments of four Rococo wallpapers were found in Uus 21 in Tallinn under a baseboard in 1980. All the examples were block-printed with distemper. Although it is not possible to reconstruct the patterns completely, it is clear that two of the patterns are made up of linear stripes intertwined with laurel leaves and berries on light blue and orange backgrounds. (**Fig. 38**) Fragments of another wallpaper show dark green leaves, flower petals and *rocaille* motifs on a light green background.

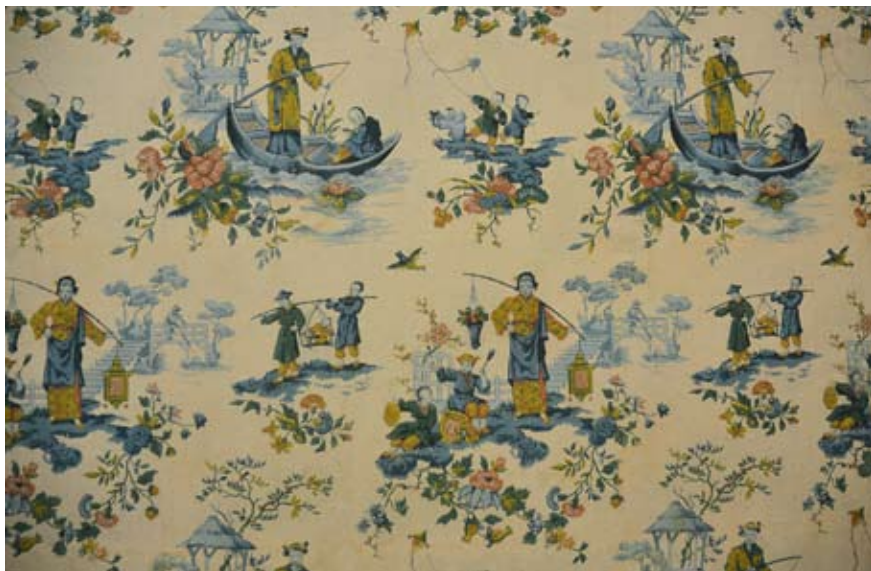
Figure 39. Chinoiserie wallpaper found in the dressing-room of Countess Manteuffel in the Puurmani manor.

of four idyllic scenes of Chinese everyday life. **(Fig. 39)** Similarly to its Chinese counterparts, the wallpaper was used to decorate a private room in a lady's apartment. This wallpaper used to cover the walls of the dressing room of Countess Manteuffel in the 1880s, before the walls were covered with a Neo-Rococo panelling. Since the wallpaper had not been removed before the new decorative layer was applied, it has survived almost intact. To make it easier to observe the wallpaper, one of the panels has been removed and replaced with glass.

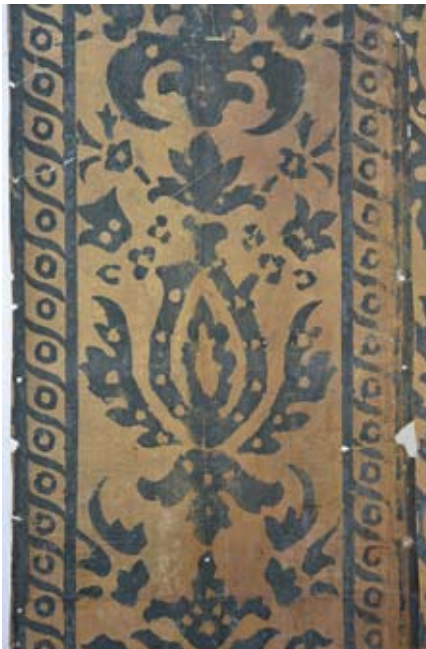
Figure 65. A stencilled wallpaper produced in the 1860s found in the Freyschlösschen in Salzburg, Austria.

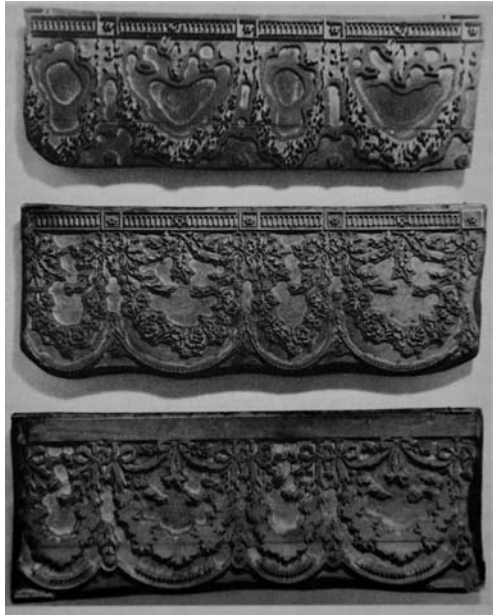
Figure 66. A number of blocks to print different colours of one design. Reproduction from *Wallpapers in Historic Preservation*, Catherine Lynn Frangiamore, Technical Preservation Services Division, Office of Archaeology and Historic Preservation, National Park Service, U.S. Department of the Interior, Washington D.C., 1977, p. 8.

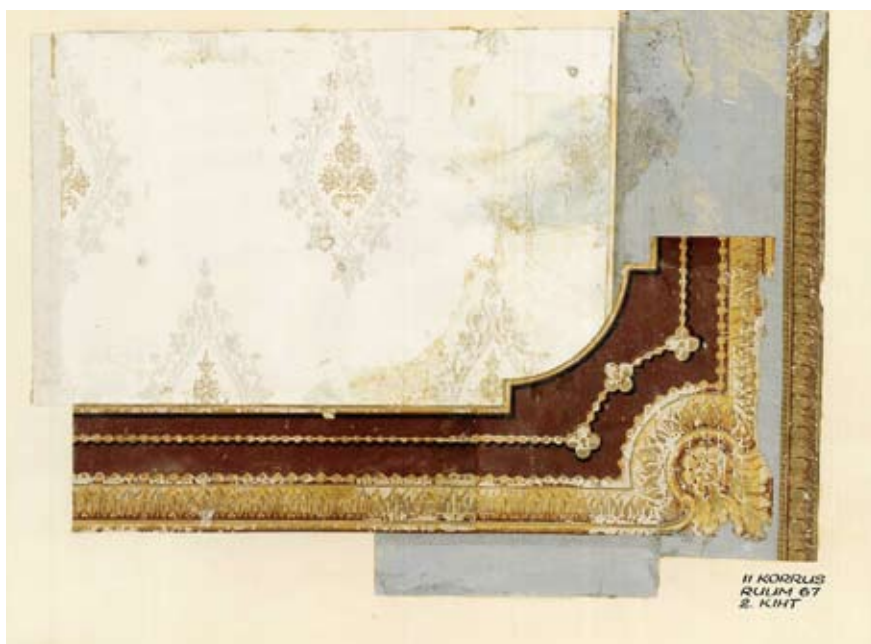
Figure 71. Fragment of a three part decorative-scheme integrating a partially gilded flock border found in Olevimägi 14, Tallinn. ERA.T-76.1.10286

Prior to printing, a strip of paper was rolled onto a 10-meter-long table. Engraved printing blocks were used to deposit glue on the surface of the paper. Before the adhesive dried, the strip of paper was placed in a long case, the bottom of which was made of soft calf skin. With the help of a sieve, the fine milled and coloured wool fibres were spread all over the adhered surface. The lid of the case was closed and two rods were used to beat the calf skin underneath. A “cloud” of woollen dust spread throughout the case and settled on sticky attached areas, forming a layer of flock. **(Fig. 70)** Freshly flocked wallpapers were dried vertically, after which loose woollen dust was carefully brushed off the paper. Other treatments, such as adding another flocked layer or overprinting with a distemper in lighter or darker shades, may have followed. **(Fig. 71)**

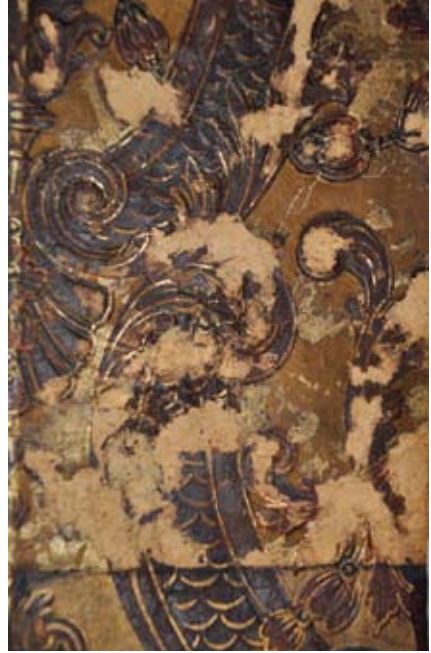
Figure 80. Wallpaper heavily damaged by careless handling during dismounting.

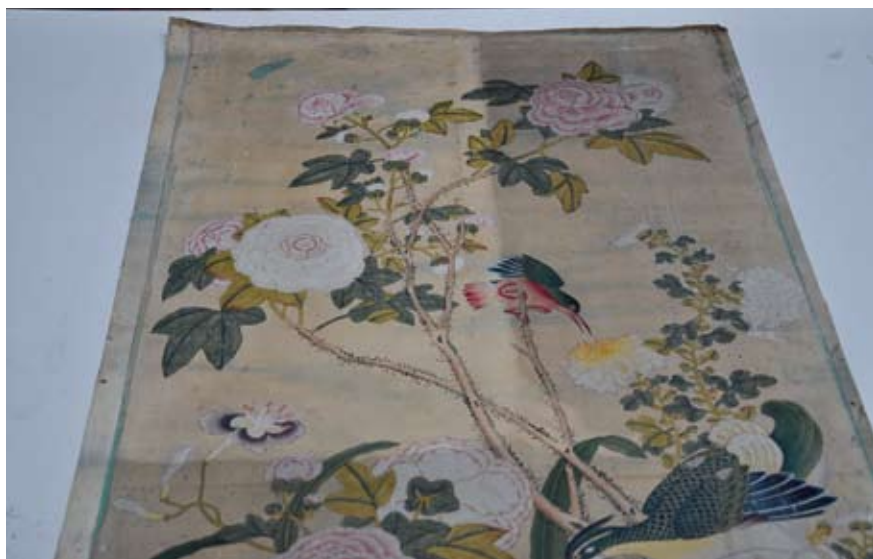
Figure 86. A test-patch made on a panel of a Chinese wallpaper from the Esterházy Palace.

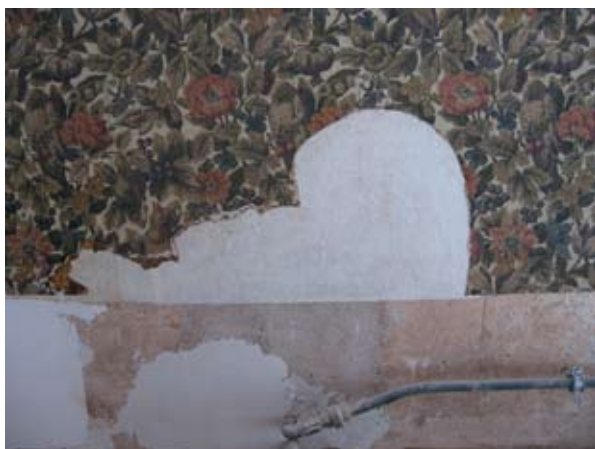
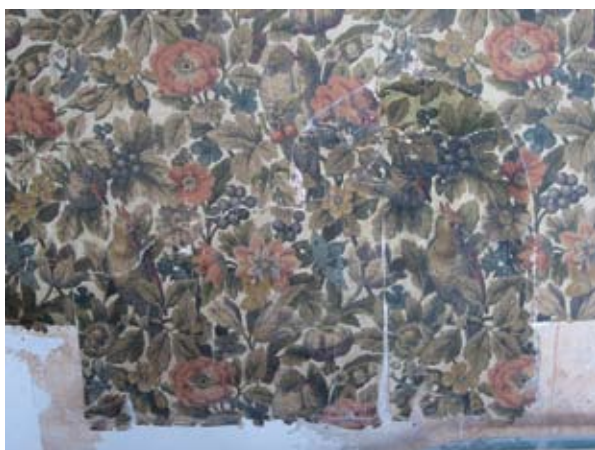
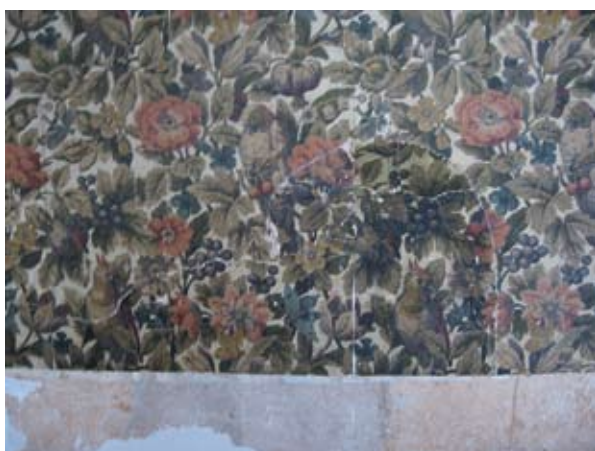
Figure 95. Large missing areas in the wallpaper were filled with fragments found behind the overdoors of the dining-room of the Puurmani manor.

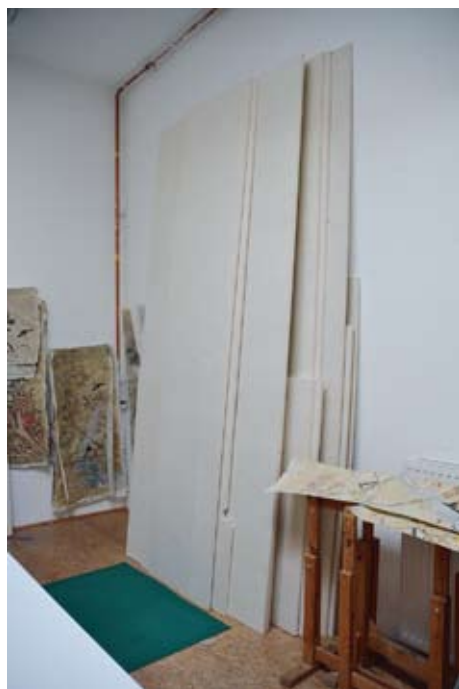
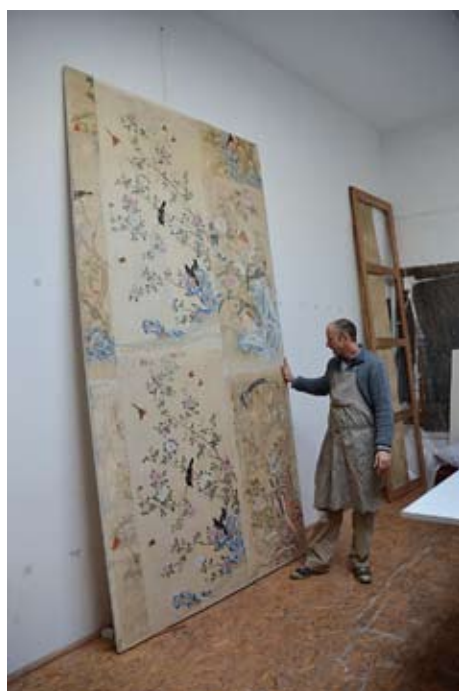
Figure 100. Large prepared *shoji* frames before and after mounting the panels of the Chinese wallpapers from the Esterhazy Palace.

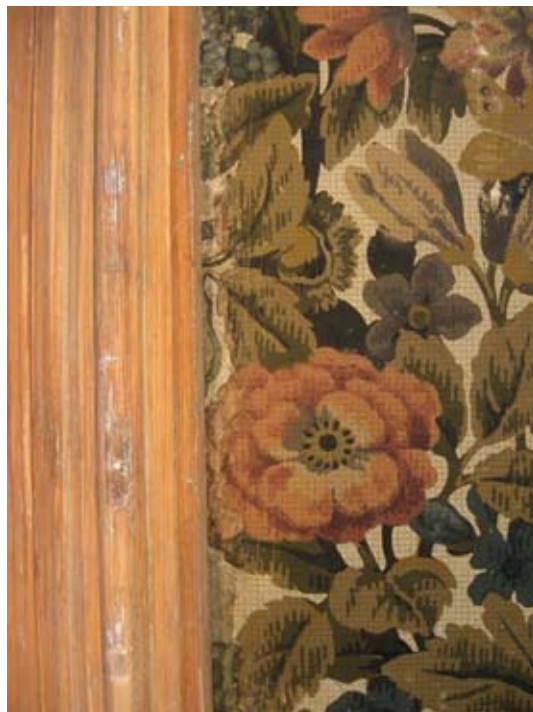
Figure 101. Missing areas in the wallpaper of the Puurmani manor's dining-room were integrated into the rest with the help of modelling lines in matching tones.

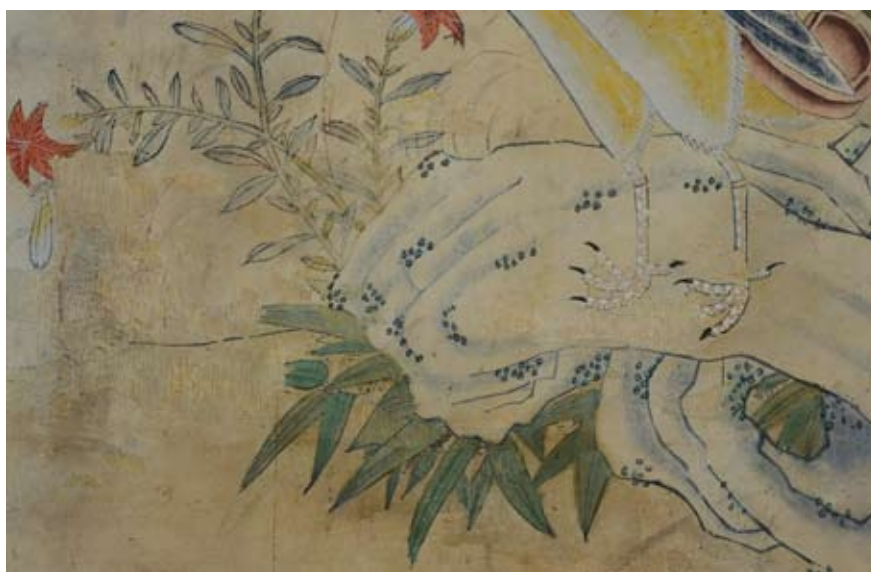
Figure 102. Large losses have been treated with a method interpreting *Tratteggio*.

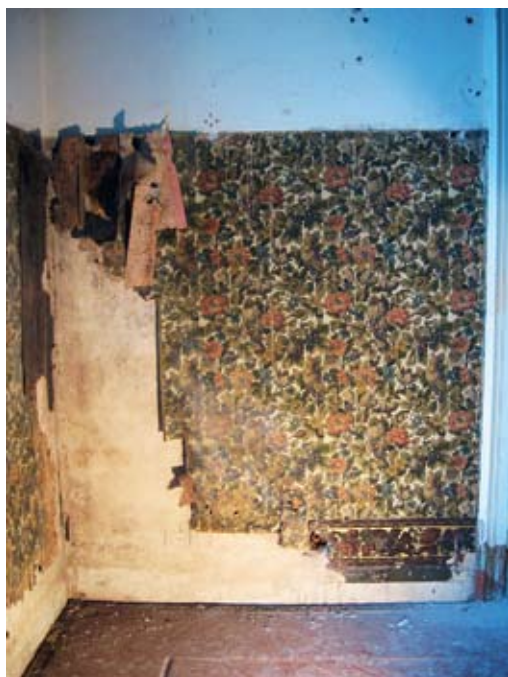
Figure 114. Corner of the dining-room badly damaged by humidity and mould.

Due to a defective rainwater pipe on the facade, the corner facing the main hall had been extensively damaged by humidity, which led to mould and discolouration of the object. **(Fig. 114)** Since five strips of heavily moulded wallpaper with borders and monochrome papers were hanging loose from the wall, it was decided to dismount and conserve them in a conservation workshop in Tartu. In addition, mechanically damaged borders from sections between windows were removed to allow for better treatment. During the conservation treatment, it became apparent that the older layer of wallpaper had been partially stripped from the wall before new wallpaper was applied. Without removing the damaged strips, it would not have become clear that only fragments of the older wallpaper had survived. Although the author had given some thought to opening and exhibiting the older layer of wallpaper within a segment of a wall, this proved to be too risky without further comprehensive research. Due to limited finances and a tight deadline, this was considered to be unreasonable. Thus it was decided to open a smaller area showing only two repeats of the pattern. Fragments

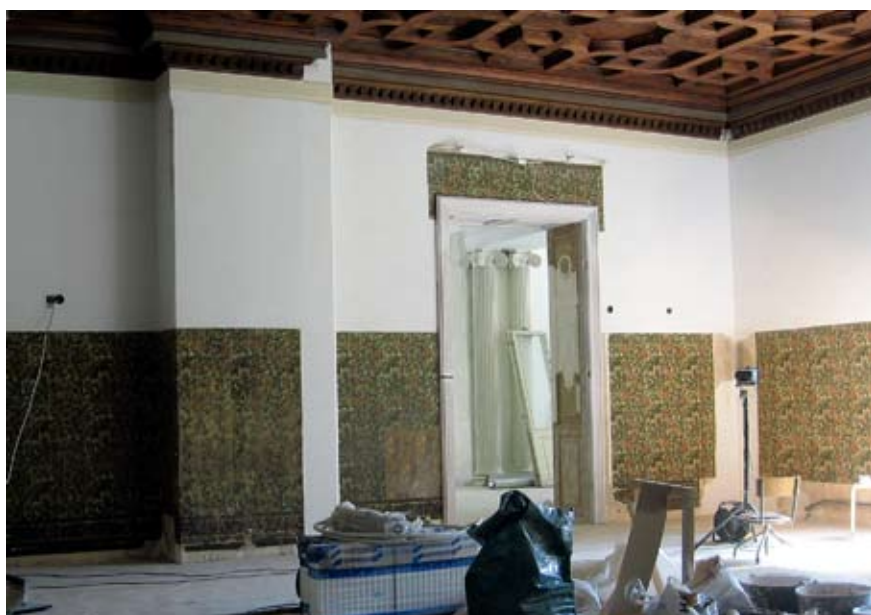
Figure 115. After removal of the wooden over-doors, large fragments of wallpaper and border were discovered.

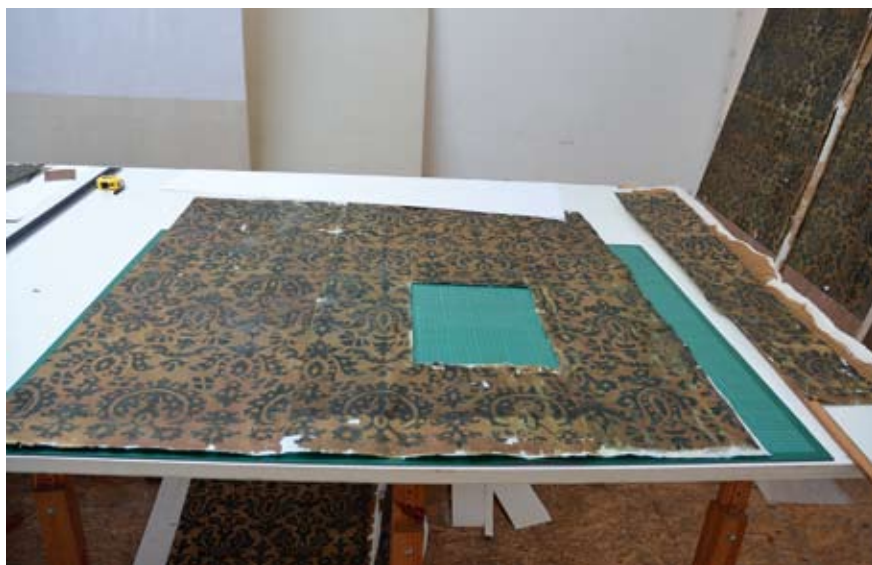
Figure 129. Conserved segments of the stencilled wallpaper.

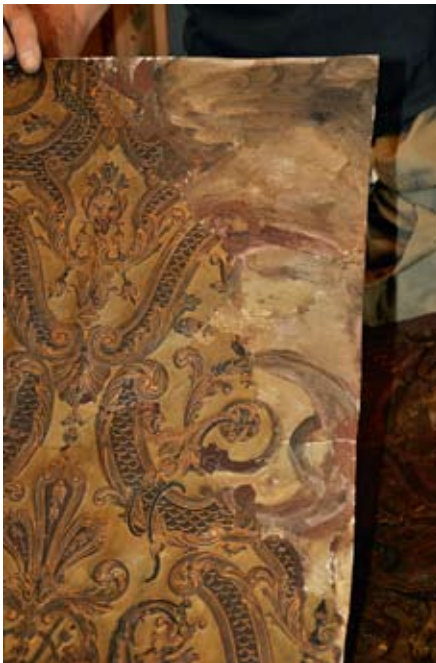
Figure 136. Poorly retouched and over-painted areas and needed to be improved.

Since removing the paint would have caused further damage, it was decided to hide the signs of the previous treatment with a layer of glazing. Large losses of over-paint were filled with streaking in neutral tones, and smaller losses were in-painted using matching neutral tones. After testing various paints, such as watercolours, gouache, gouache with acrylic binder, acrylic paint, crayons and pastels, it was decided that the texture and

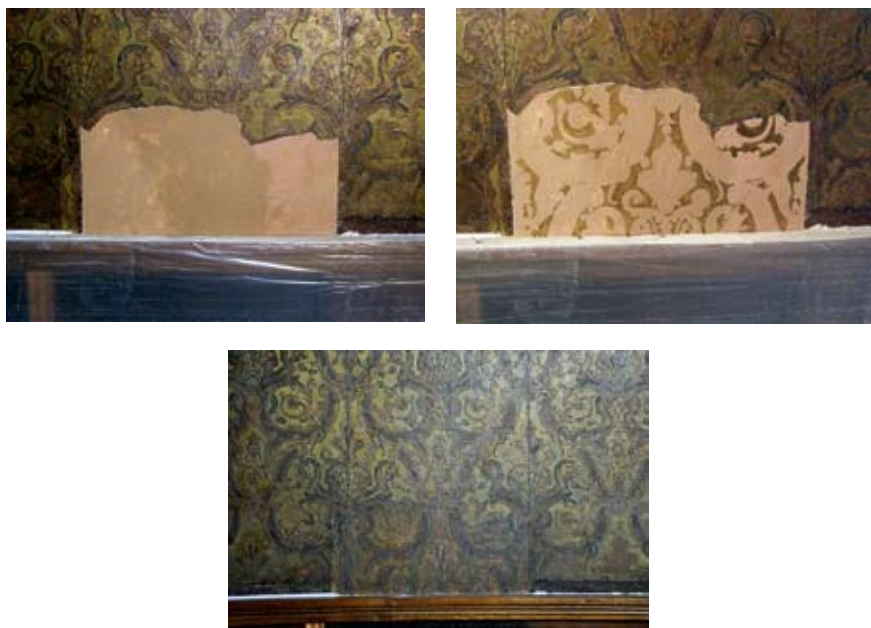
Figure 139. The reconstruction was painted *in situ*.

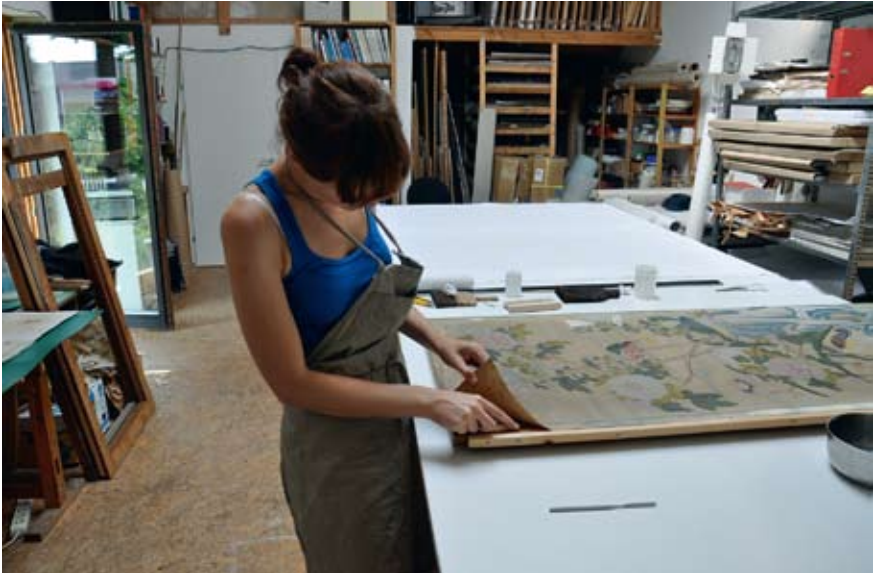
Figure 144. Prior to dry-cleaning the wallpaper panels needed to be removed from the wooden frames.

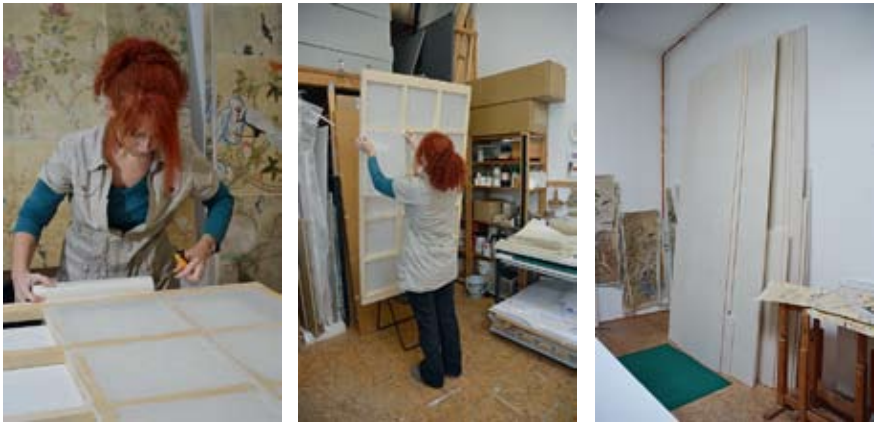
Figure 146. Applying the layers of Japanese tissue to form the so-called air-pocket system.

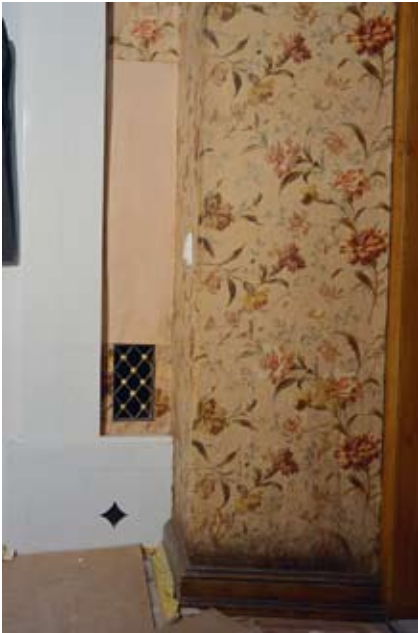
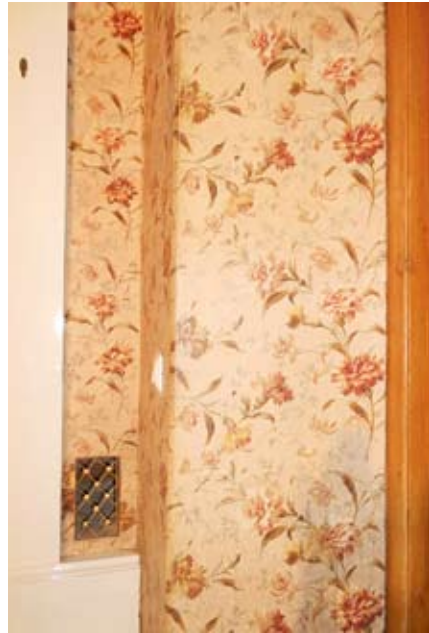
Figure 161. Missing area before and after reconstruction *in situ*.

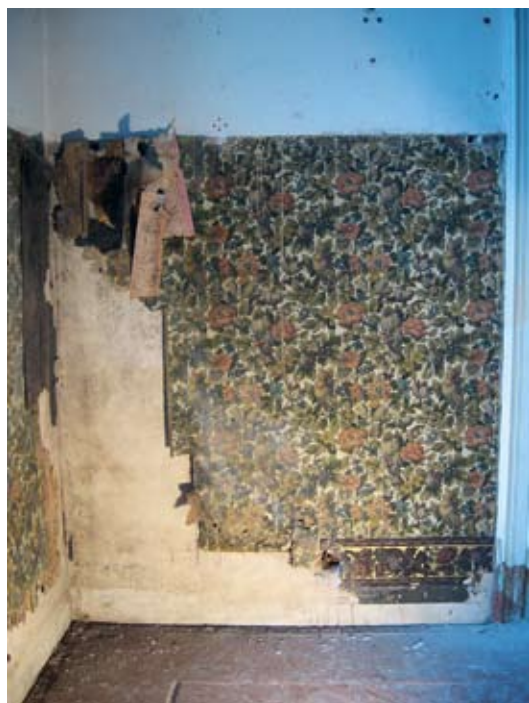
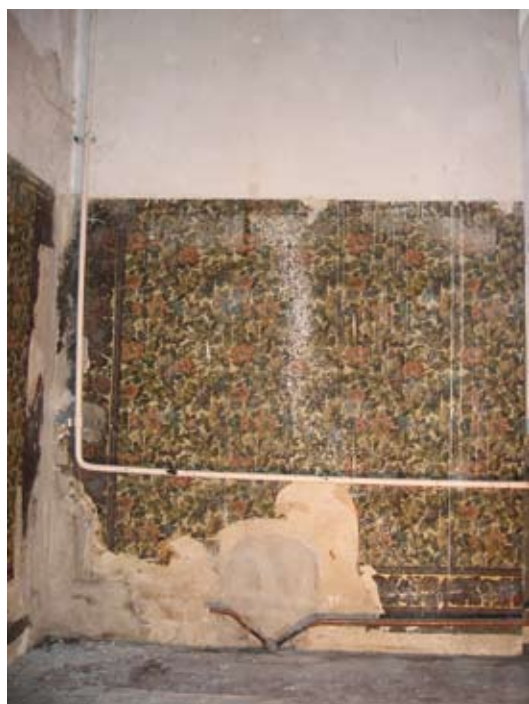
Figure 170. Condition of the wallpaper after the removal of the wooden paneling.

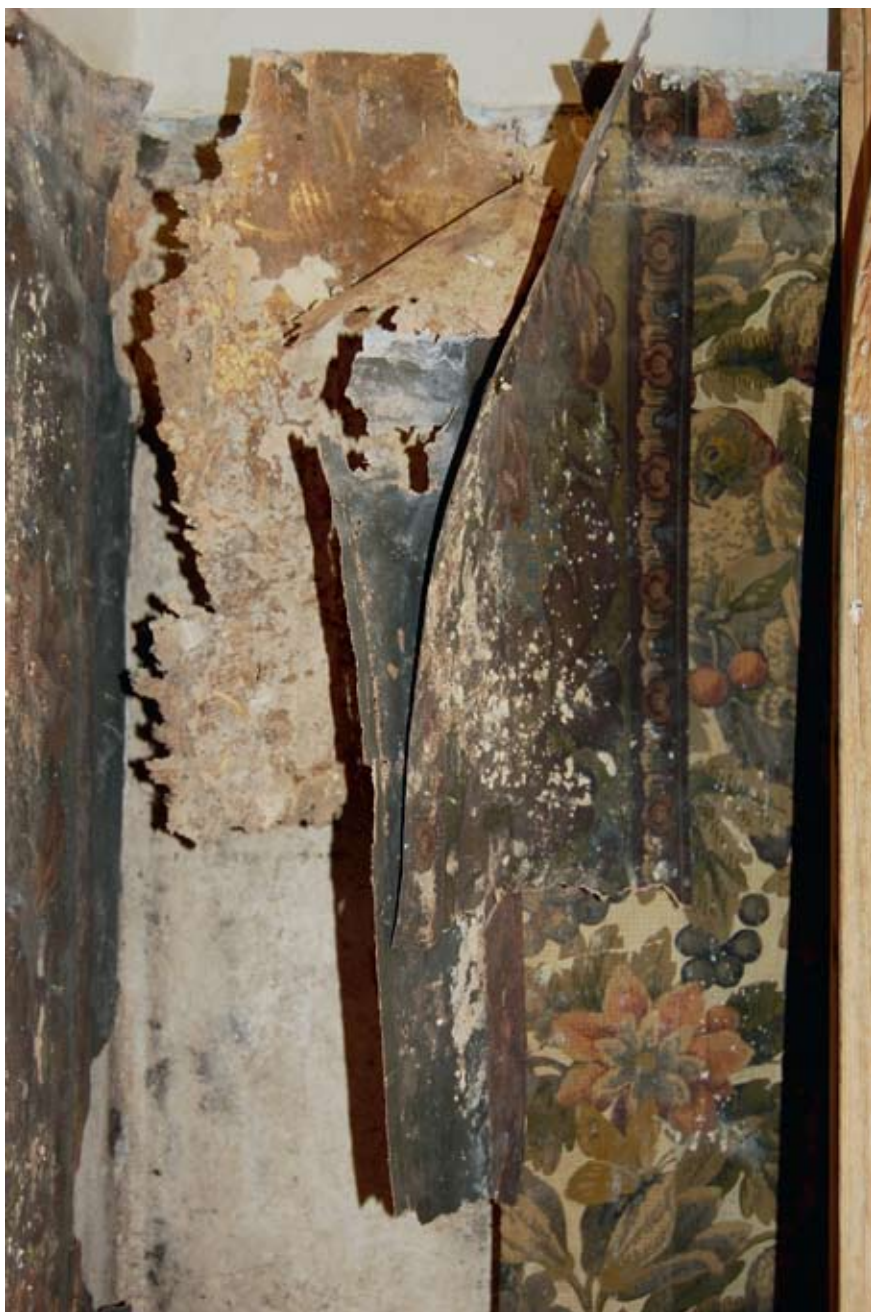
Figure 171. Heavily moulded area.

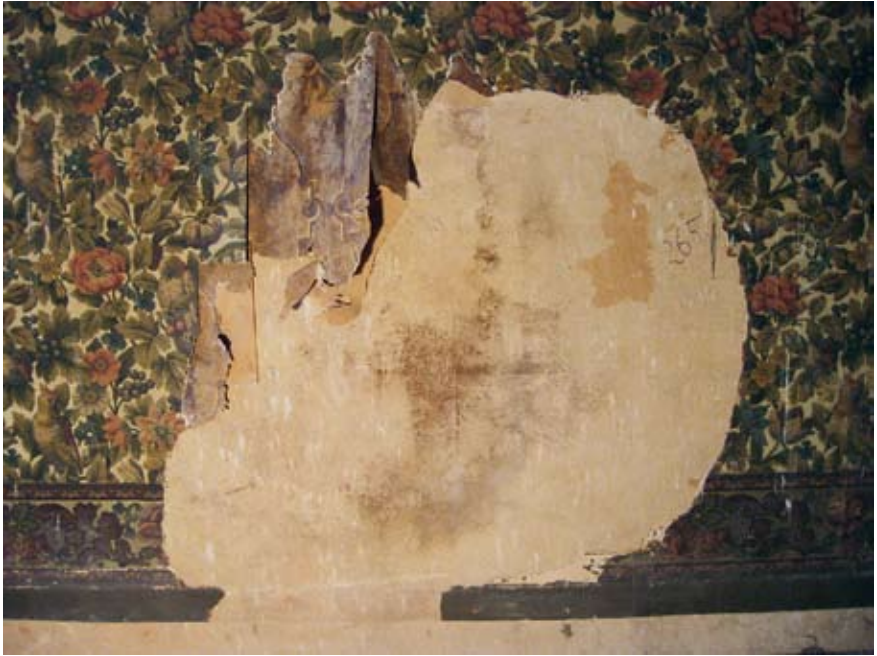
Figure 172. Large area of missing wallpaper.

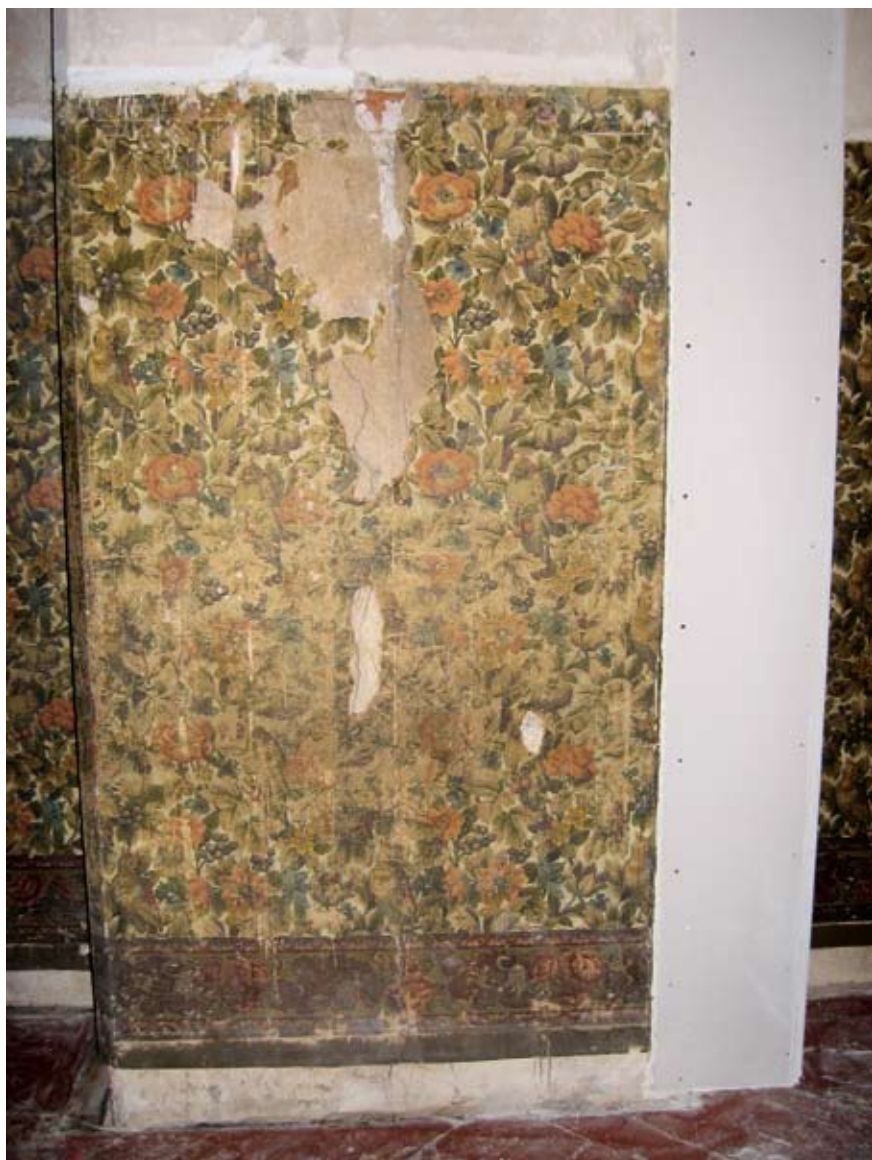
Figure 173. Discoloured and mechanically damaged area.

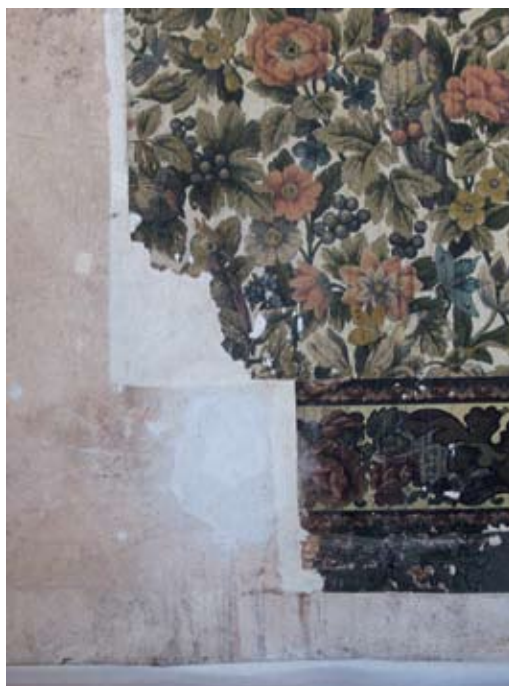
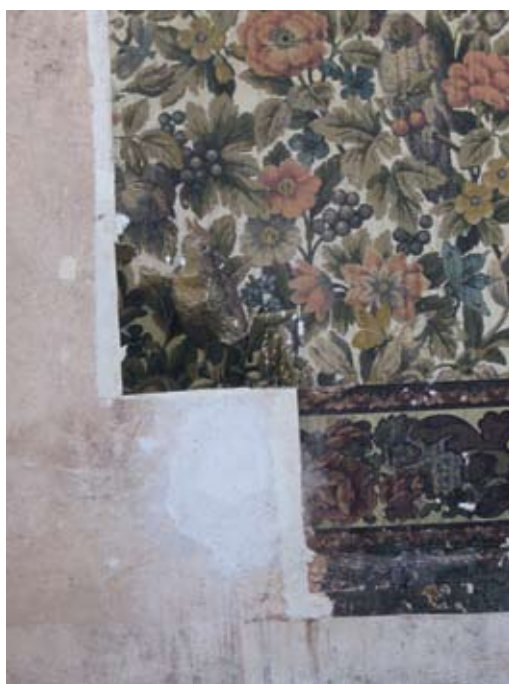
Figure 180. Small missing areas were filled with the wallpaper fragments found behind the wooden overdoors.

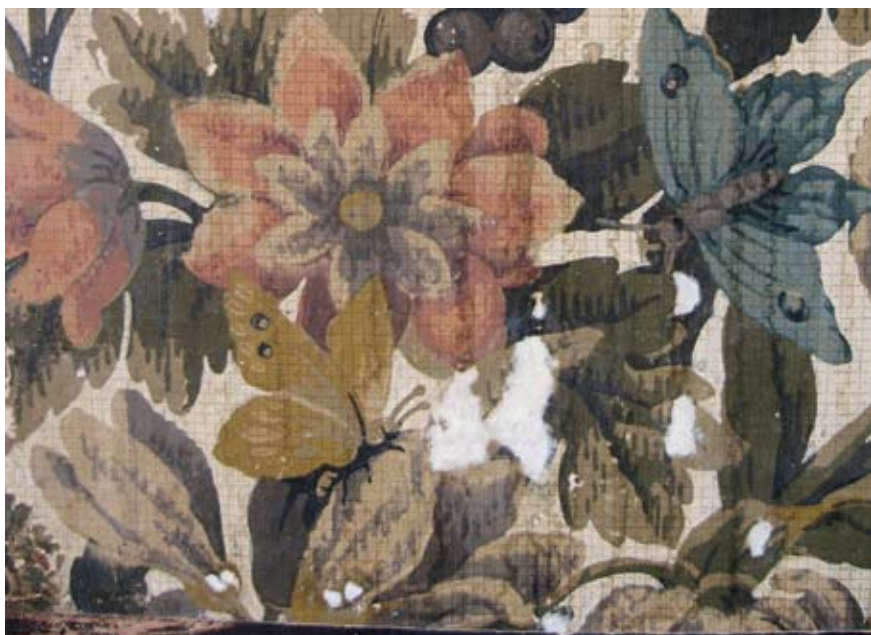
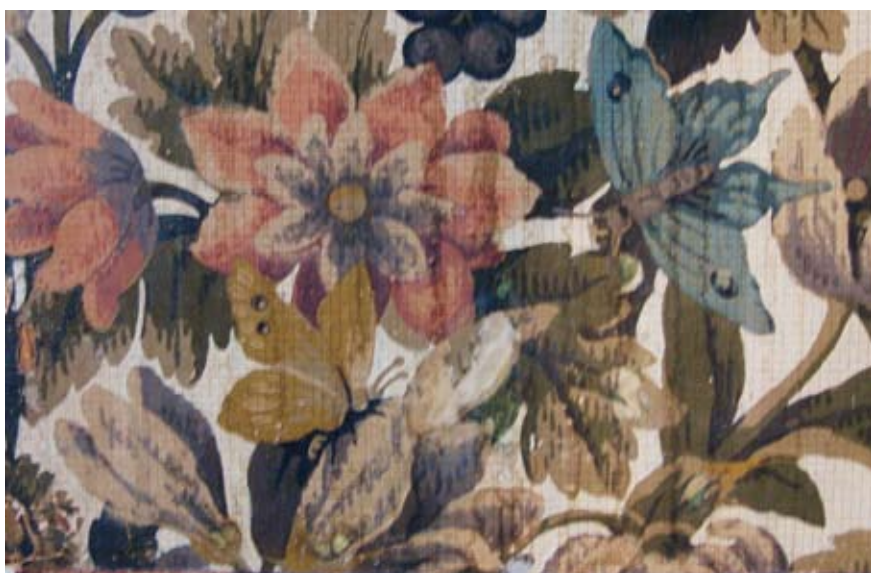
Figure 181. Tiny holes made by insects were filled with a fine layer of paper paste.

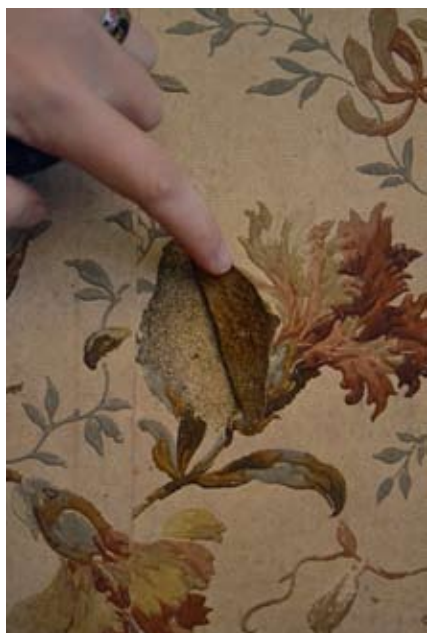
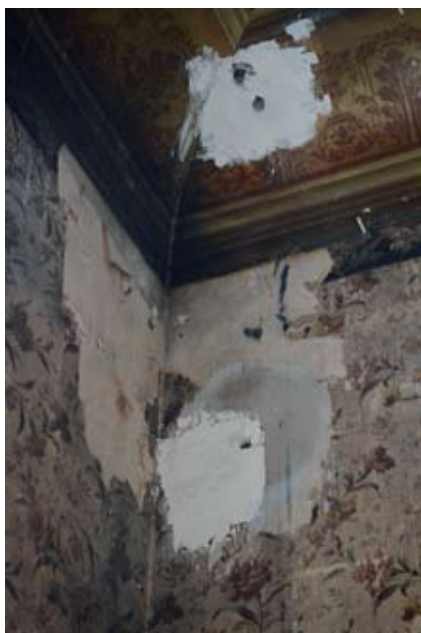
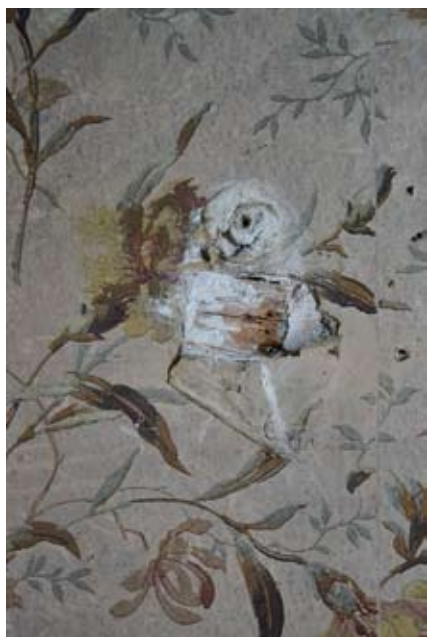
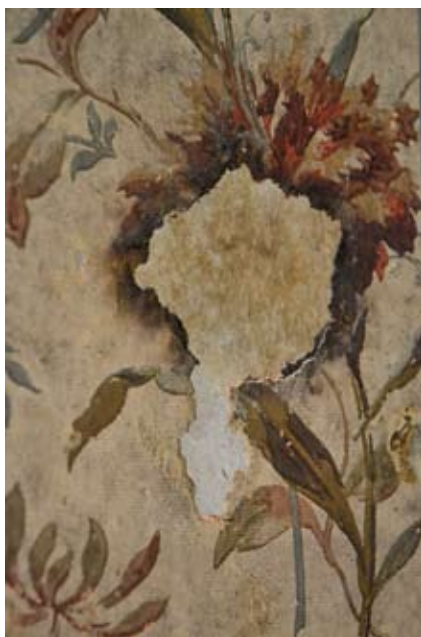
Figure 186. Different types of damages.

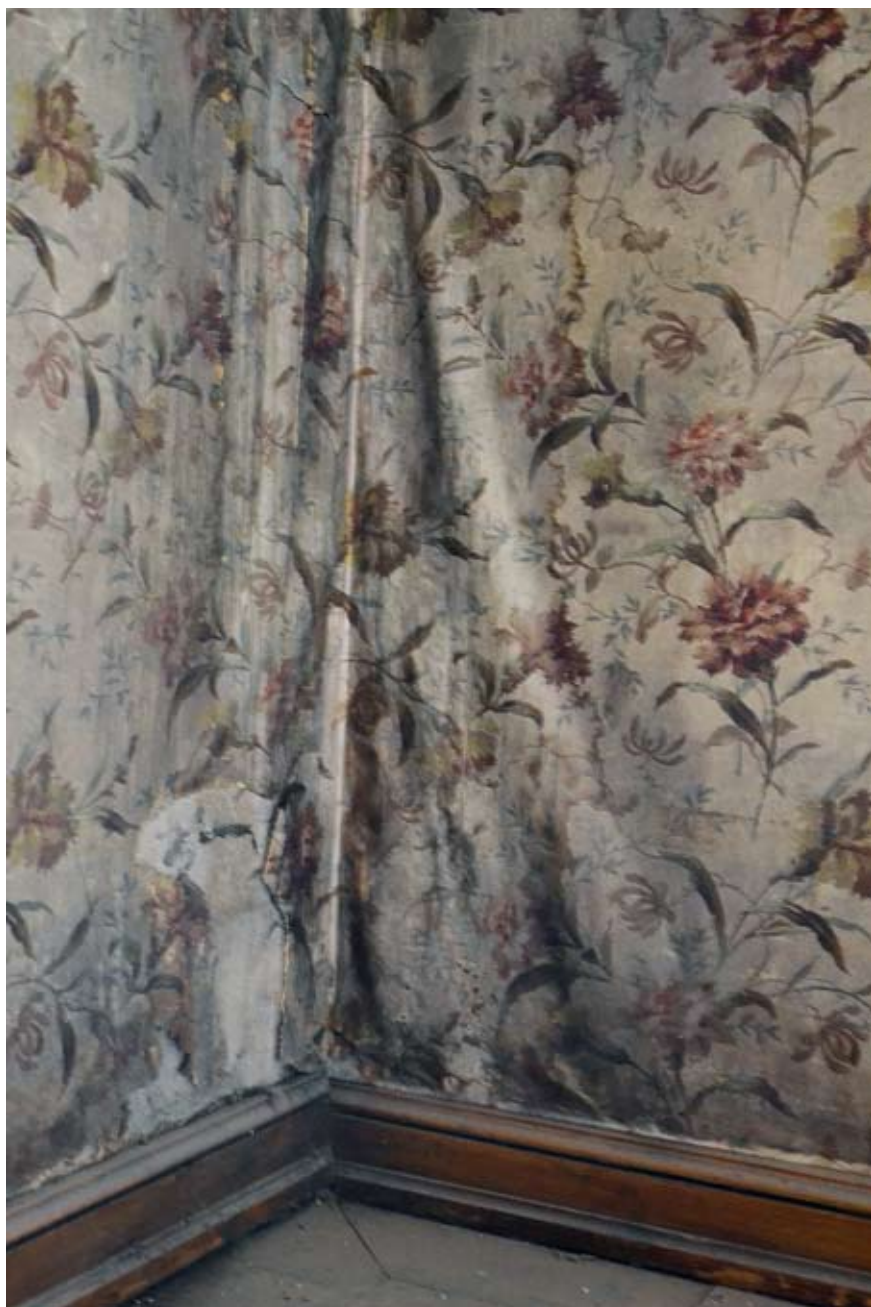
Figure 187. Corner damaged by humidity and dark tidelines.

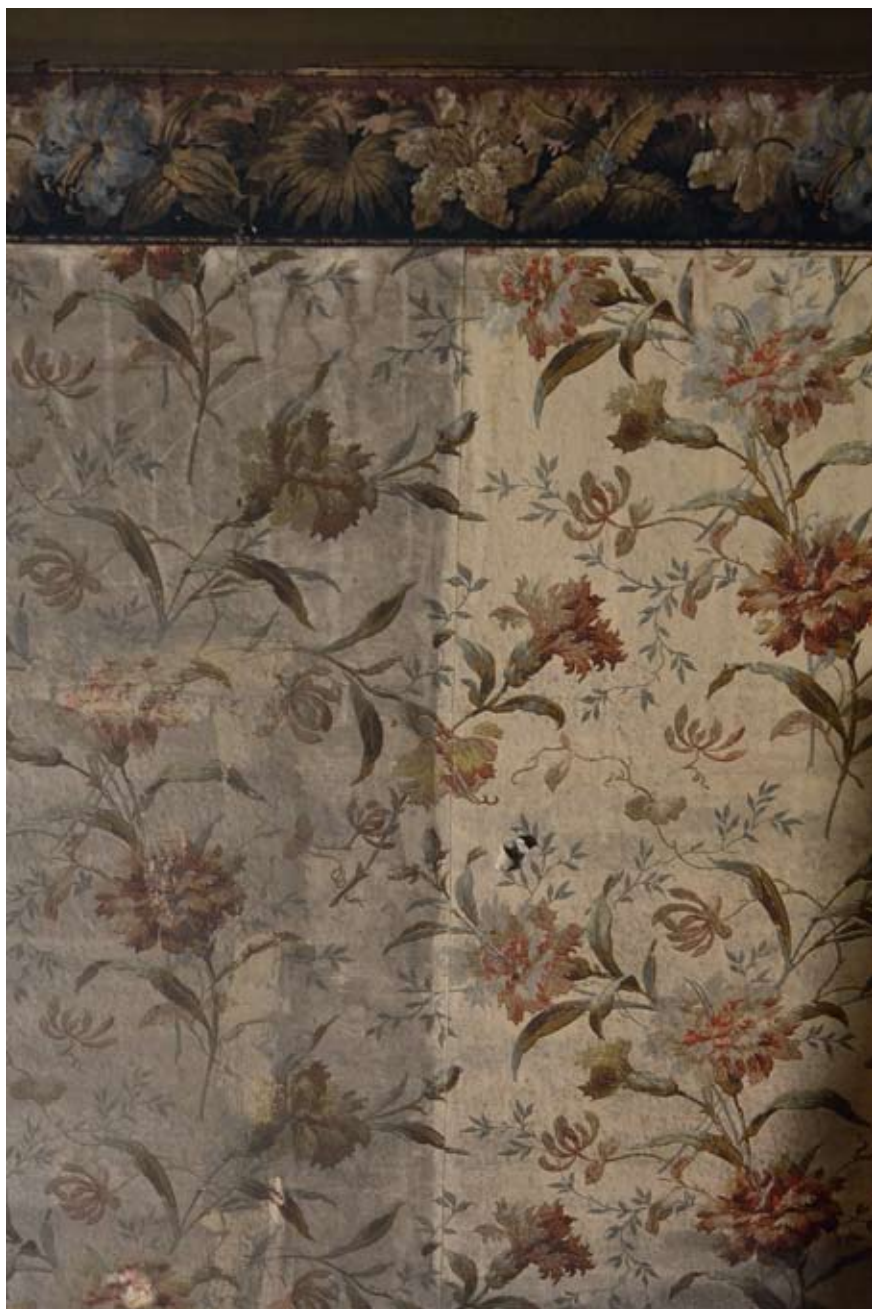
Figure 188. Test patch of dry-cleaning.

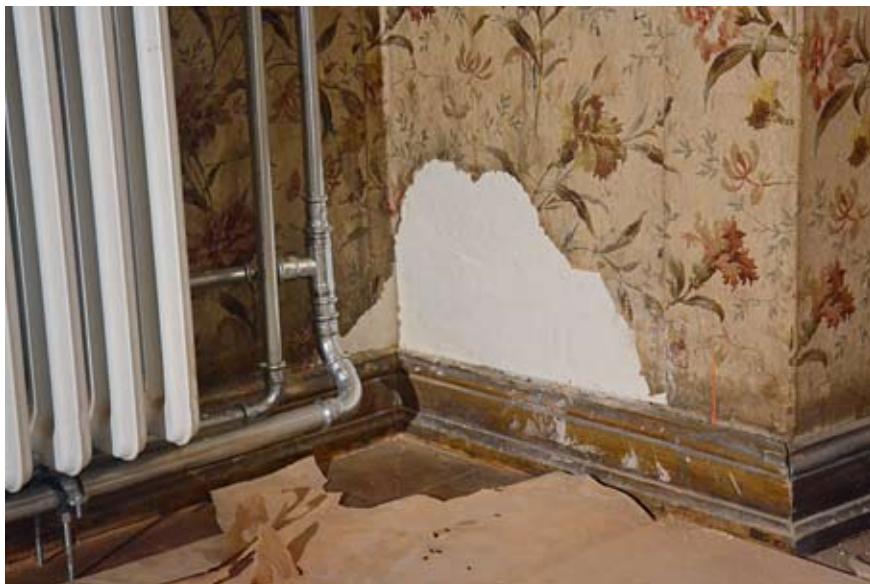
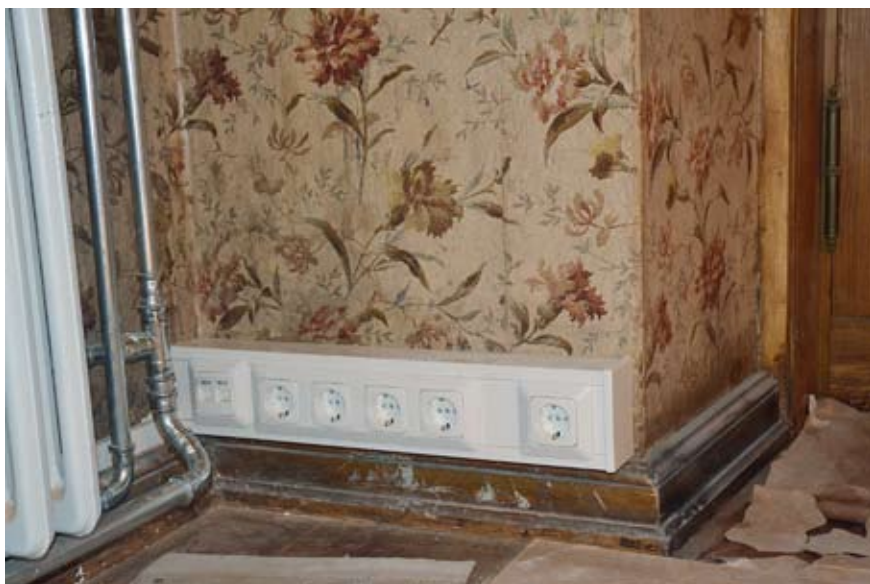
Figure 190. Smaller missing areas could be filled with the material removed from behind of the radiator.

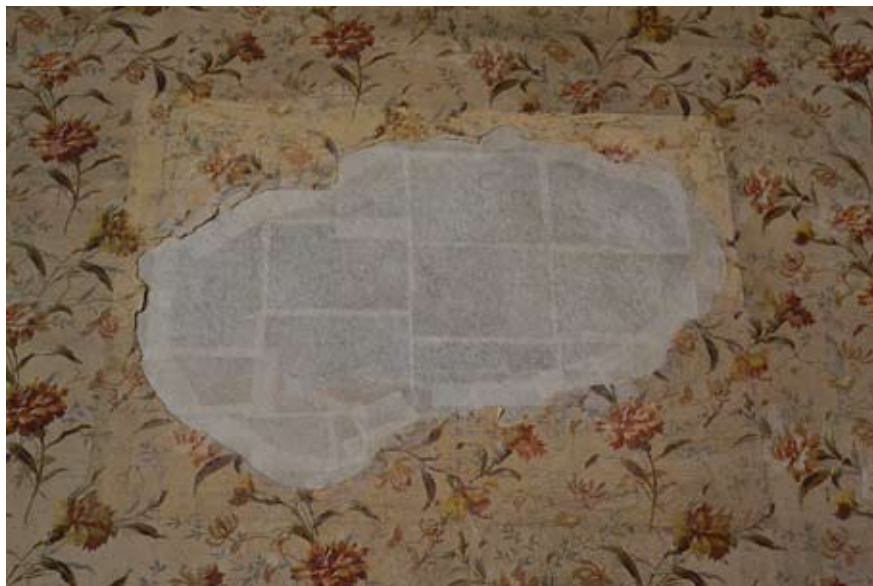
Figure 191. Large missing area was revealed after the removal of the archival paper.

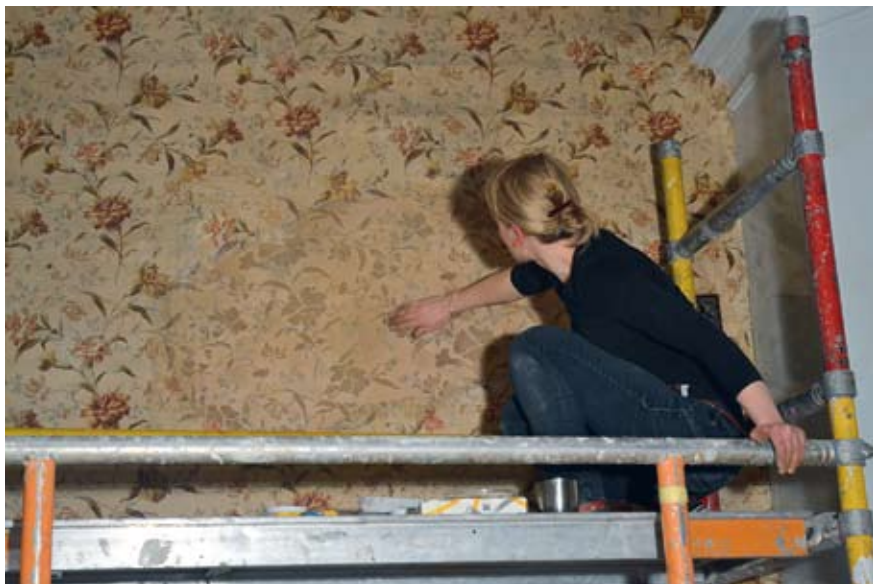
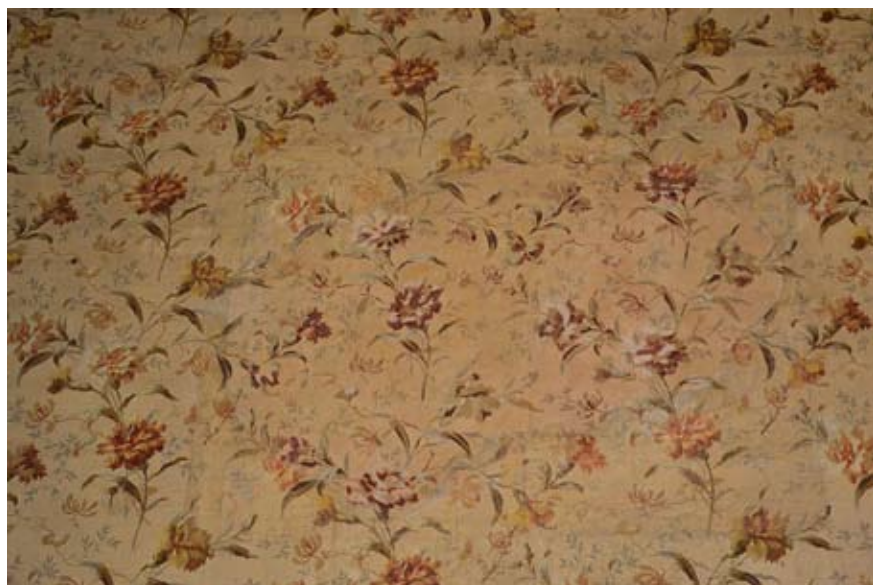
Figure 192. The missing area was reconstructed in situ by using stencils and painting.
